Manhole Inspection Summary

Manhole # S25CC_006MH

Insp Date: **10/17/07 9:35 AM**

Location Address: **1046 ARLINGTON AVE**

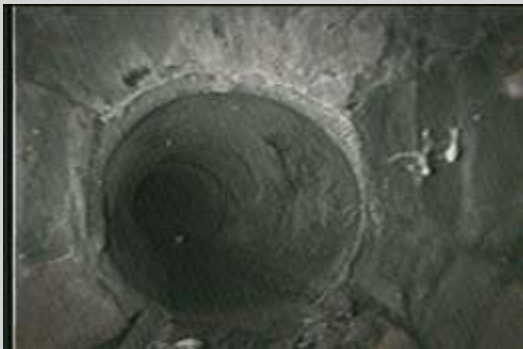
Pipe In @ 3 O'Clock

8 in. Circular Gravity Sewer

Pipe Material: **Clay** ☐ Pipe Lined

Infiltration: **None** Pipe Seal Cond: **Unknown**
